## **Remediation of the high-level radwaste repositories at Russian Research Center “Kurchatov Institute”**

**Abstract.** The paper presents peculiarities of organization and performance of activities on disposition of the high level activity radwaste repository located at the radwaste disposal site of the Russian Research Center “Kurchatov Institute” in Moscow. The process of the radwaste extraction from the repository is described in comparison with similar activities in other old repositories. Tools and equipment used for the radwaste extraction from the repository are listed. Conventional construction machines equipped with a hydraulic hammer or a clamshell were used for destruction of the concrete-encased radwaste mass and extraction of low-level radwaste. Intermediate- and high-level radwaste was extracted by remotely controlled robots operating inside the shielding structure. Gamma visor was used for detection of high-level radwaste or fragments in the mass concrete being destroyed and for pointing remotely controlled robots accordingly. The paper describes peculiarities of radiation monitoring in the course of operations on disposition of the repository. For rapid detectio

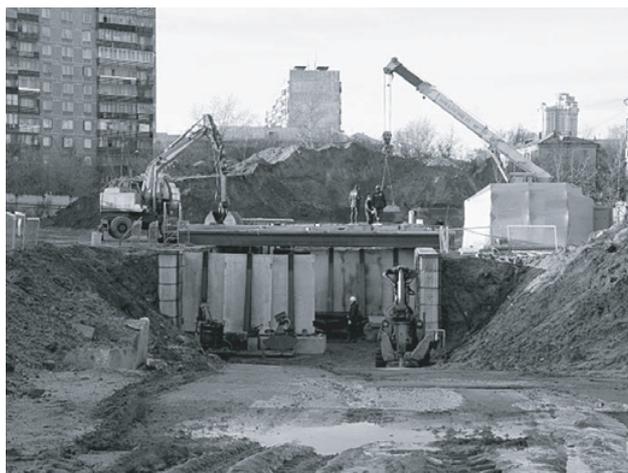
**Figure 1.** A view of the radiation shield of repository No 4.

The presence of high-level waste in the repository No 4 has required preliminary radiation monitoring of its contents, as well as computational assessments of possible changes of the radiation situation near the repository due to its opening and high-level waste extraction and removal operations. This was determined by the repository’s location in the immediate vicinity of the Center’s secured perimeter and high apartment houses. Computations have shown that the liquidation of this repository requires an external radiation shield. External support walls made of foundation blocks sized 600 × 600 × 2400 mm and reinforced with metallic trusses, which served as a basement for the external covering structure made

of 6-m pavement slabs (20 cm thick, Fig. 1). A labyrinth was constructed to allow robots' entering the operational area without any direct radiation releases from the radiation shield.

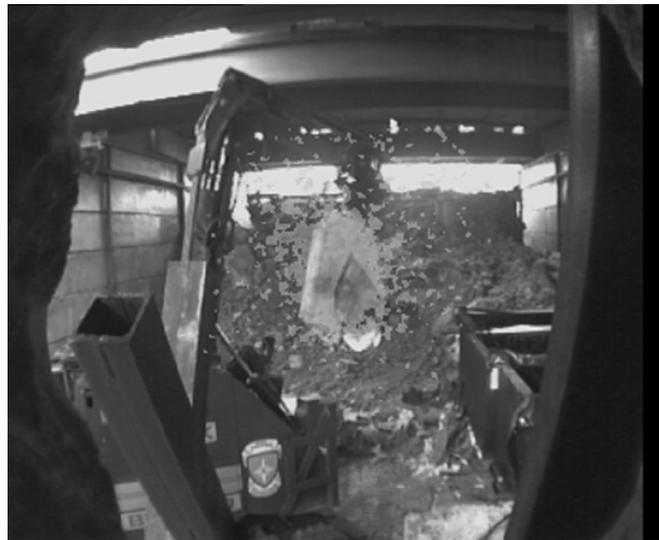
**Figure 2.** The moment of high-level radiation source’s removal by the robot. This image was obtained using the gamma visor.

The storage monolith was destroyed through upper apertures in the radiation shield using an excavator equipped with a hydraulic hammer. A gamma visor generating the signal displayed on the operator's monitor was used to detect canisters containing high-level waste in the destroyed monolith [1–3]. Removal of canisters containing high-level waste was a non-routine situation carried out by robots in conditions of high radiation fields (up to several dozens mSv/h). When canisters containing high-level waste were detected in the repository No 4, its upper radiation shield cover was restored completely, and high-level waste extraction, activity measurements and packaging was performed by robots inside the shield, with no personnel present in the high radiation area. Robots destroyed residues of the concrete waste matrix, gripped the detected high-level waste and removed them to the special grading area arranged inside the radiation shield. Within this area, robots performed all waste separation, cutting and packaging operations. Robots' steering to high-level sources, as well as these sources' extraction, fragmentation and packaging into containers were controlled on the gamma visor monitor (Fig. 2). High-level waste was placed into special KRAD-2,7 containers with 250-mm-thick concrete insert, and were removed from under the radiation shield in a packaged form ready for transportation to MosNPO Radon for long-term disposal.

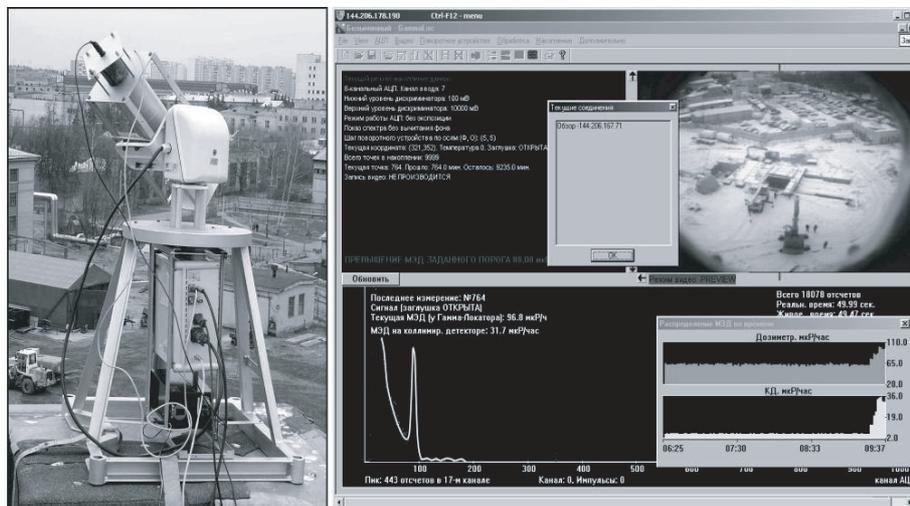
**Figure 3.** Image on the screen of the gamma locator during the works in repository No 4 (with shady shielding in place).

The radiation situation in the operational area and at the whole site during the works on the repository No 4 was controlled by two gamma locators, which measured the flux of ionizing radiation photons with account of its spectrographic parameters [4]. One gamma locator performed continuous monitoring of radiation situation in the operational areas of repository No 4, displaying the measured data on personal computer monitors via an Internet line. The second gamma locator scanned the whole site of old repositories and performed spot measurement of gamma spectra in its selected spots (Fig. 3). Based on the photon flux distribution data, gamma dose rates were calculated for all spots of the scanned area, which were represented in form of a color palette superposed on the calibrated image of the scanned object.

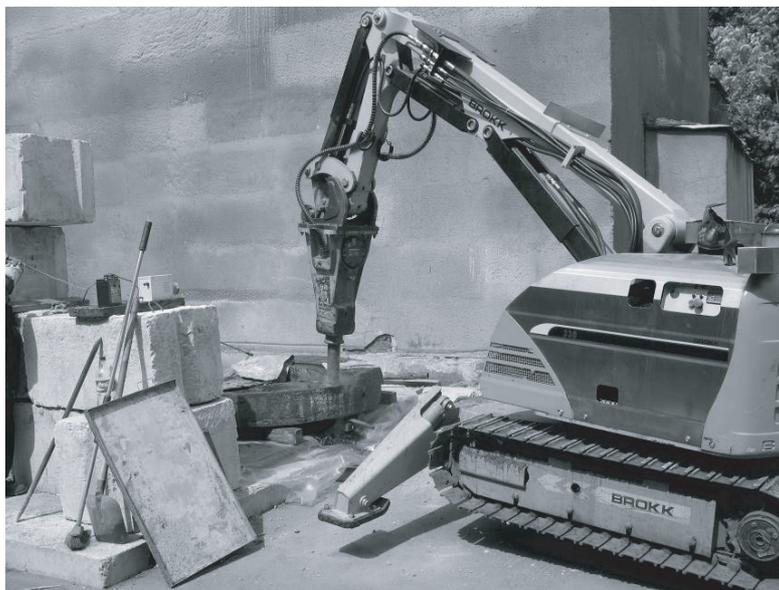
**Figure 4.** Destruction of a semi-ring by Brokk-330 hydraulic hammer.

High-level protective semi-rings of the reactor were conditioned at a special site, where loaded and shipping-ready containers with radwaste have been previously stored. Brokk-33-robot placed semi-rings onto special slipways, and a drilling facility's rotary core bit bored holes in it along the semi-ring's symmetry axis. These works were performed using dust-suppression means in low-speed drilling mode. The personnel was used only in the process of steering the drilling facility to the boring spot.

Then Brokk-330, with its hydraulic hammer, broke semi-rings into two parts (Fig. 4) and packaged its halves into KRAD-2,7 container. Then contaminated waste and sand were added to fill the container.
